# Home Report

Hazelbank  
South Street  
Burrelton  
PH13 9PE

# single survey

<b>Property address</b>	Hazelbank South Street Burrelton PH13 9PE
<b>Customer</b>	Mr W McNaughton for Margaret McNaughton`s Executry
<b>Prepared by</b>	Graham + Sibbald LLP

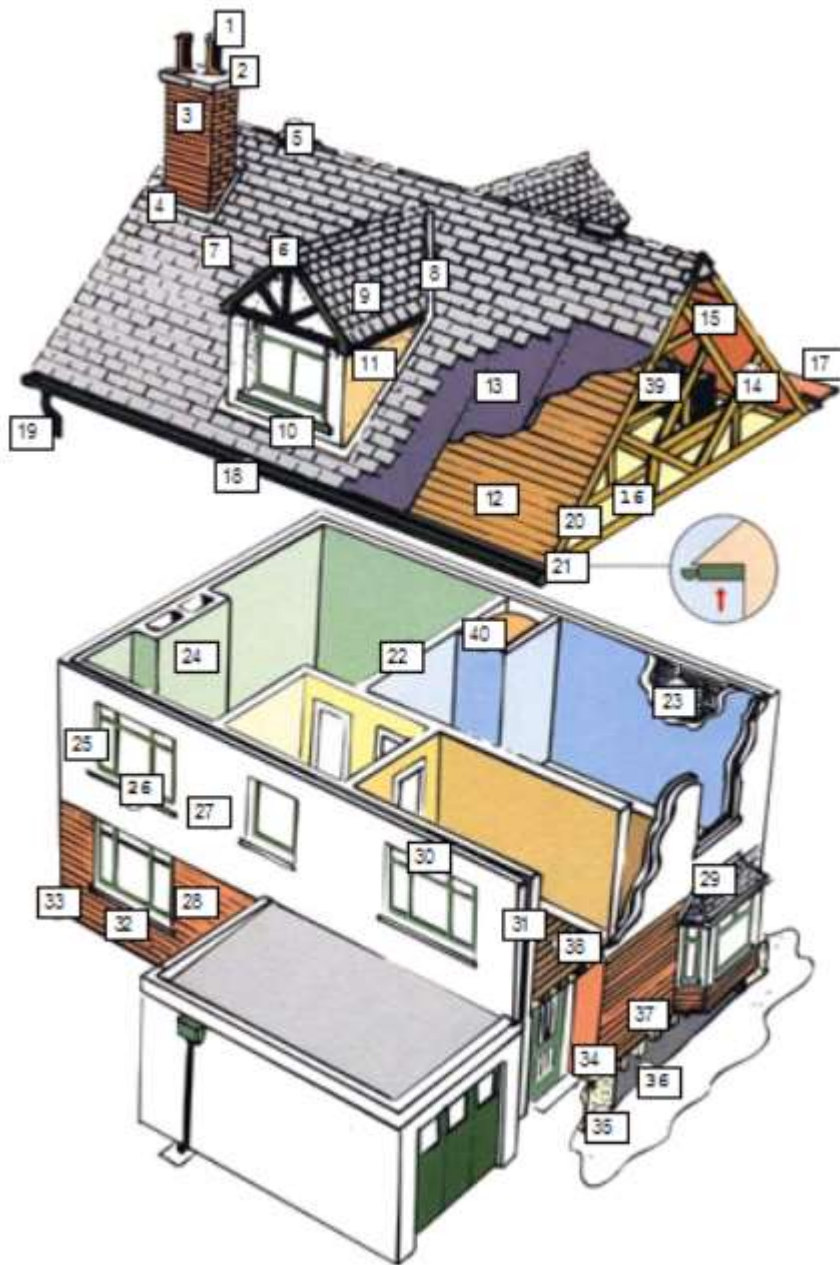
## Sectional Diagram showing elements of a typical house

1	Chimney pots
2	Coping stone
3	Chimney head
4	Flashing
5	Ridge ventilation
6	Ridge board
7	Slates/tiles
8	Valley guttering
9	Dormer projection
10	Dormer flashing
11	Dormer cheeks
12	Sarking
13	Roof felt
14	Trusses
15	Collar
16	Insulation
17	Parapet gutter
18	Eaves guttering
19	Rainwater downpipe
20	Verge boards / skewes
21	Soffit boards
22	Partition wall
23	Lath / plaster
24	Chimney breast
25	Window pointing
26	Window sills
27	Rendering
28	Brickwork / pointing
29	Bay window
30	Lintels
31	Cavity walls / wall ties
32	Subfloor ventilator
33	Damp proof course
34	Base course
35	Foundations
36	Solum
37	Floor joists
38	Floorboards
39	Water tank
40	Hot water tank

Reference may be made in this report to some or all of the above component parts of the property. This diagram may assist you in locating and understanding these items.

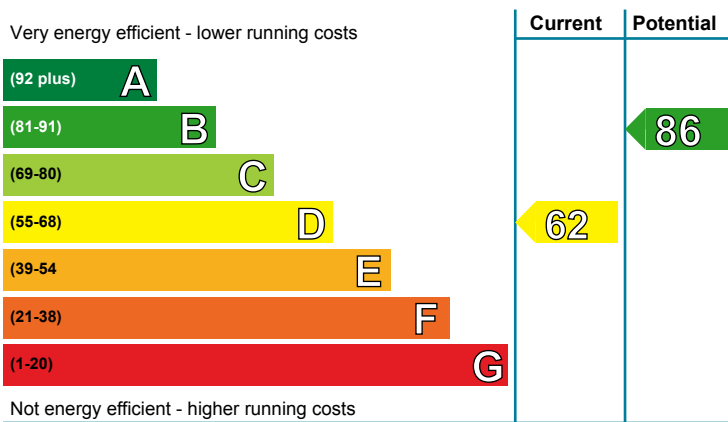
## Energy Efficiency Rating

This graph shows the current efficiency of your home, taking into account both energy efficiency and fuel costs. The higher this rating, the lower your fuel bills are likely to be.

Your current rating is **band D (62)**. The average rating for EPCs in Scotland is **band D (61)**.

The potential rating shows the effect of undertaking all of the improvement measures listed within your recommendations report.

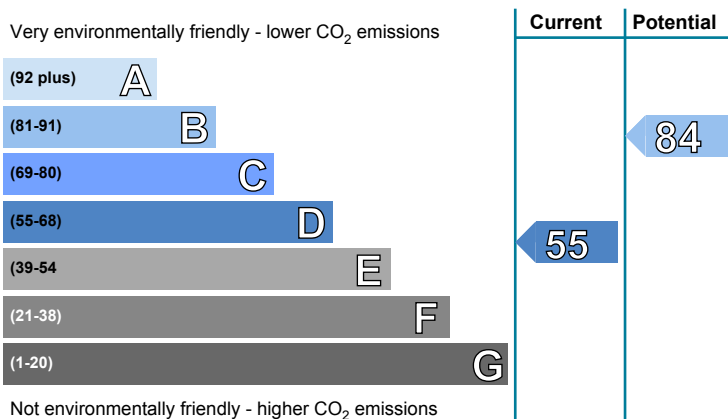
## Environmental Impact (CO<sub>2</sub>) Rating

This graph shows the effect of your home on the environment in terms of carbon dioxide (CO<sub>2</sub>) emissions. The higher the rating, the less impact it has on the environment.
