# Home Report

33 Ardblair Road  
Blairgowrie  
PH10 6QA

# single survey

<b>Property address</b>	33 Ardblair Road Blairgowrie PH10 6QA
<b>Customer</b>	Gordon + Elizabeth Philip
<b>Prepared by</b>	Graham + Sibbald LLP

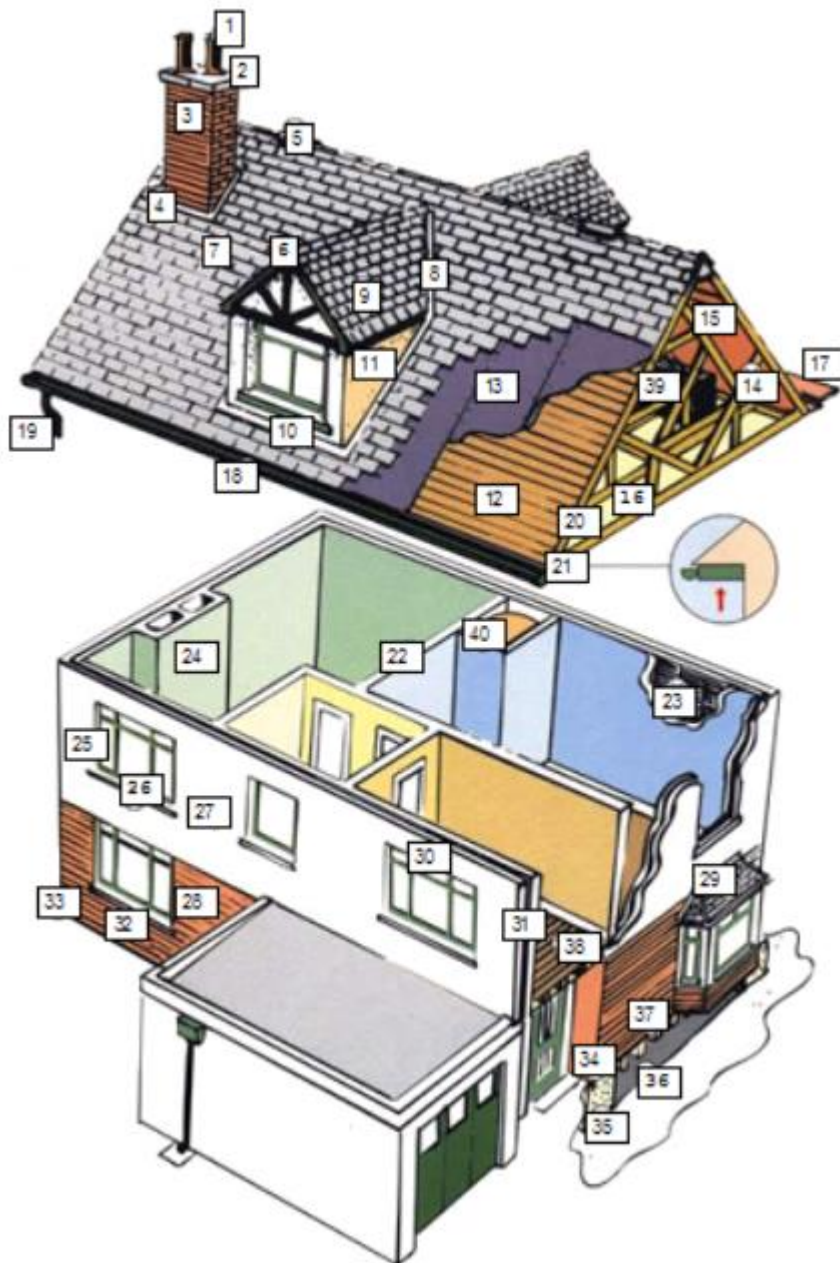
## Sectional Diagram showing elements of a typical house

1	Chimney pots
2	Coping stone
3	Chimney head
4	Flashing
5	Ridge ventilation
6	Ridge board
7	Slates/tiles
8	Valley guttering
9	Dormer projection
10	Dormer flashing
11	Dormer cheeks
12	Sarking
13	Roof felt
14	Trusses
15	Collar
16	Insulation
17	Parapet gutter
18	Eaves guttering
19	Rainwater downpipe
20	Verge boards / skewes
21	Soffit boards
22	Partition wall
23	Lath / plaster
24	Chimney breast
25	Window pointing
26	Window sills
27	Rendering
28	Brickwork / pointing
29	Bay window
30	Lintels
31	Cavity walls / wall ties
32	Subfloor ventilator
33	Damp proof course
34	Base course
35	Foundations
36	Solum
37	Floor joists
38	Floorboards
39	Water tank
40	Hot water tank

Reference may be made in this report to some or all of the above component parts of the property. This diagram may assist you in locating and understanding these items.
